Investigation of Deterioration of Joints in Concrete Pavements

National Concrete Pavement
Technology Center

Final Report
August 2012

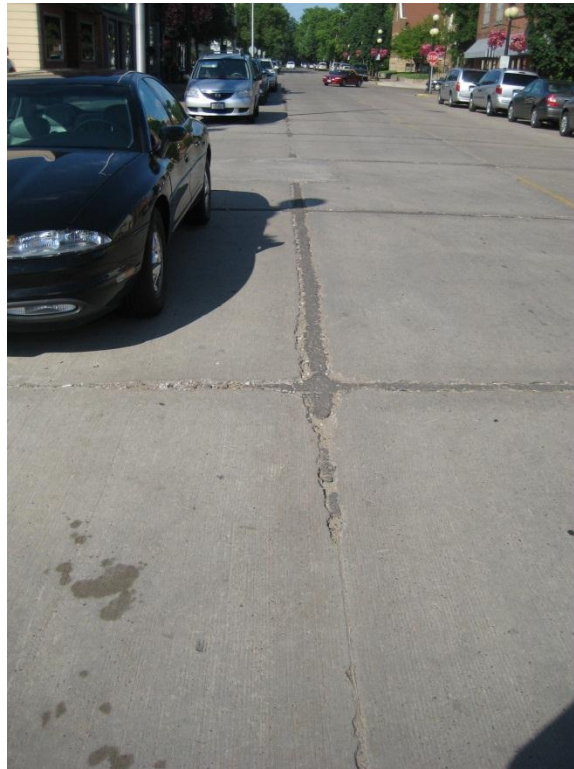
Figure 1. Grand Avenue

The intersection of First Avenue and Grand Avenue is in a local commercial area. It is a lightly-trafficked T junction. Distress was easily observed in the joints (Figures 1 and 2) on Grand Avenue, but not as apparent on First Avenue.

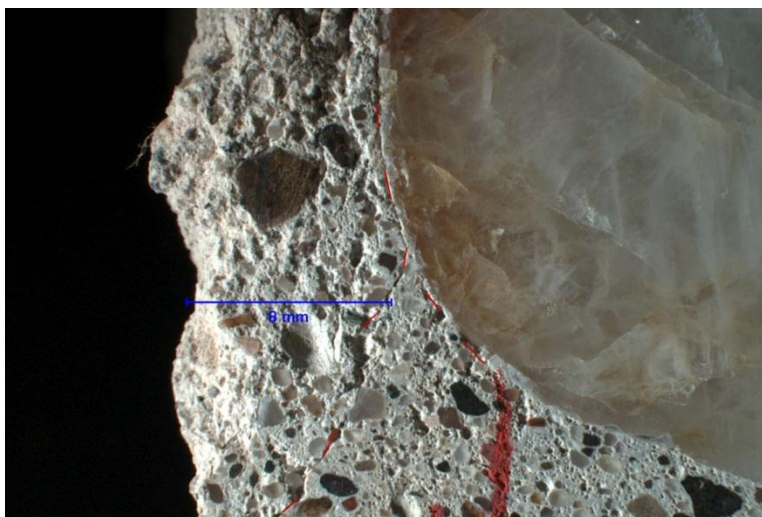
Figure 3. Cracks concentrated adjacent to the coarse aggregate in FG1

It is noted in one of the images, FG1 shows cracking propagating around the coarse aggregate (Figure 3).

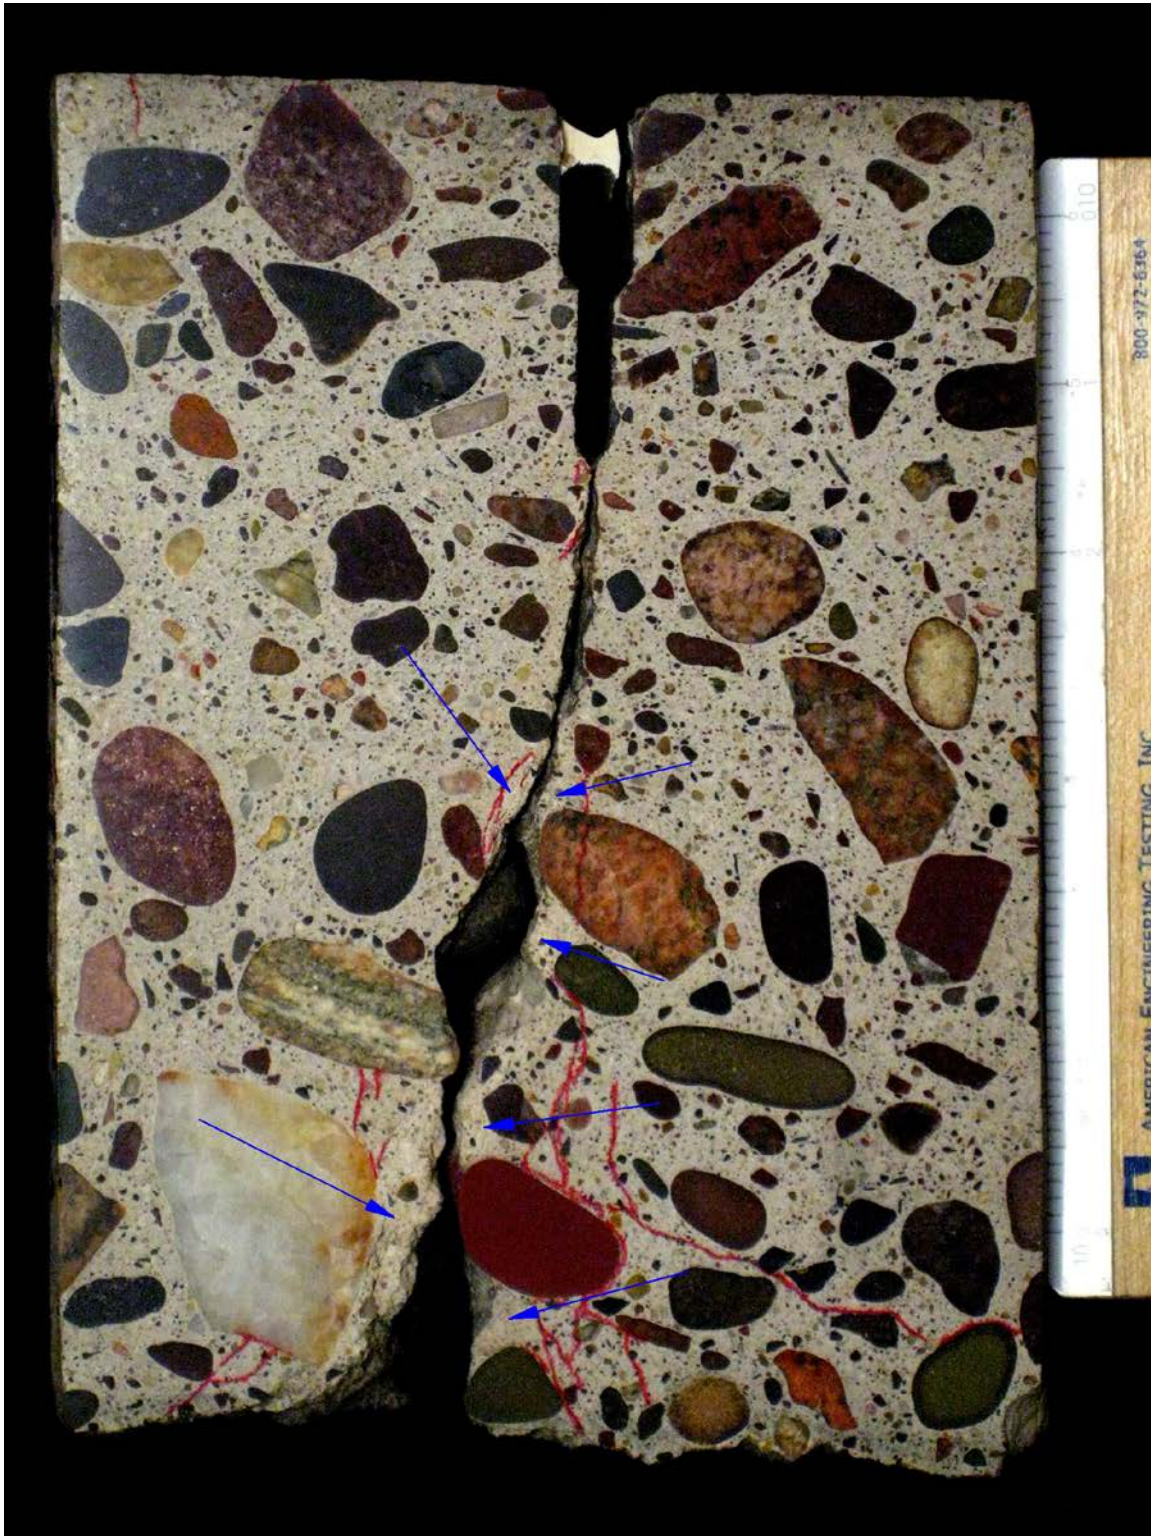
PHOTO: 9

SAMPLE ID: FG-1 **DESCRIPTION:** Sawcut and lapped cross section of core taken through a sawcut control joint. Some microcracking is mapped in red ink. Heavily concentrated microcracking and distressed paste is marked with arrows.

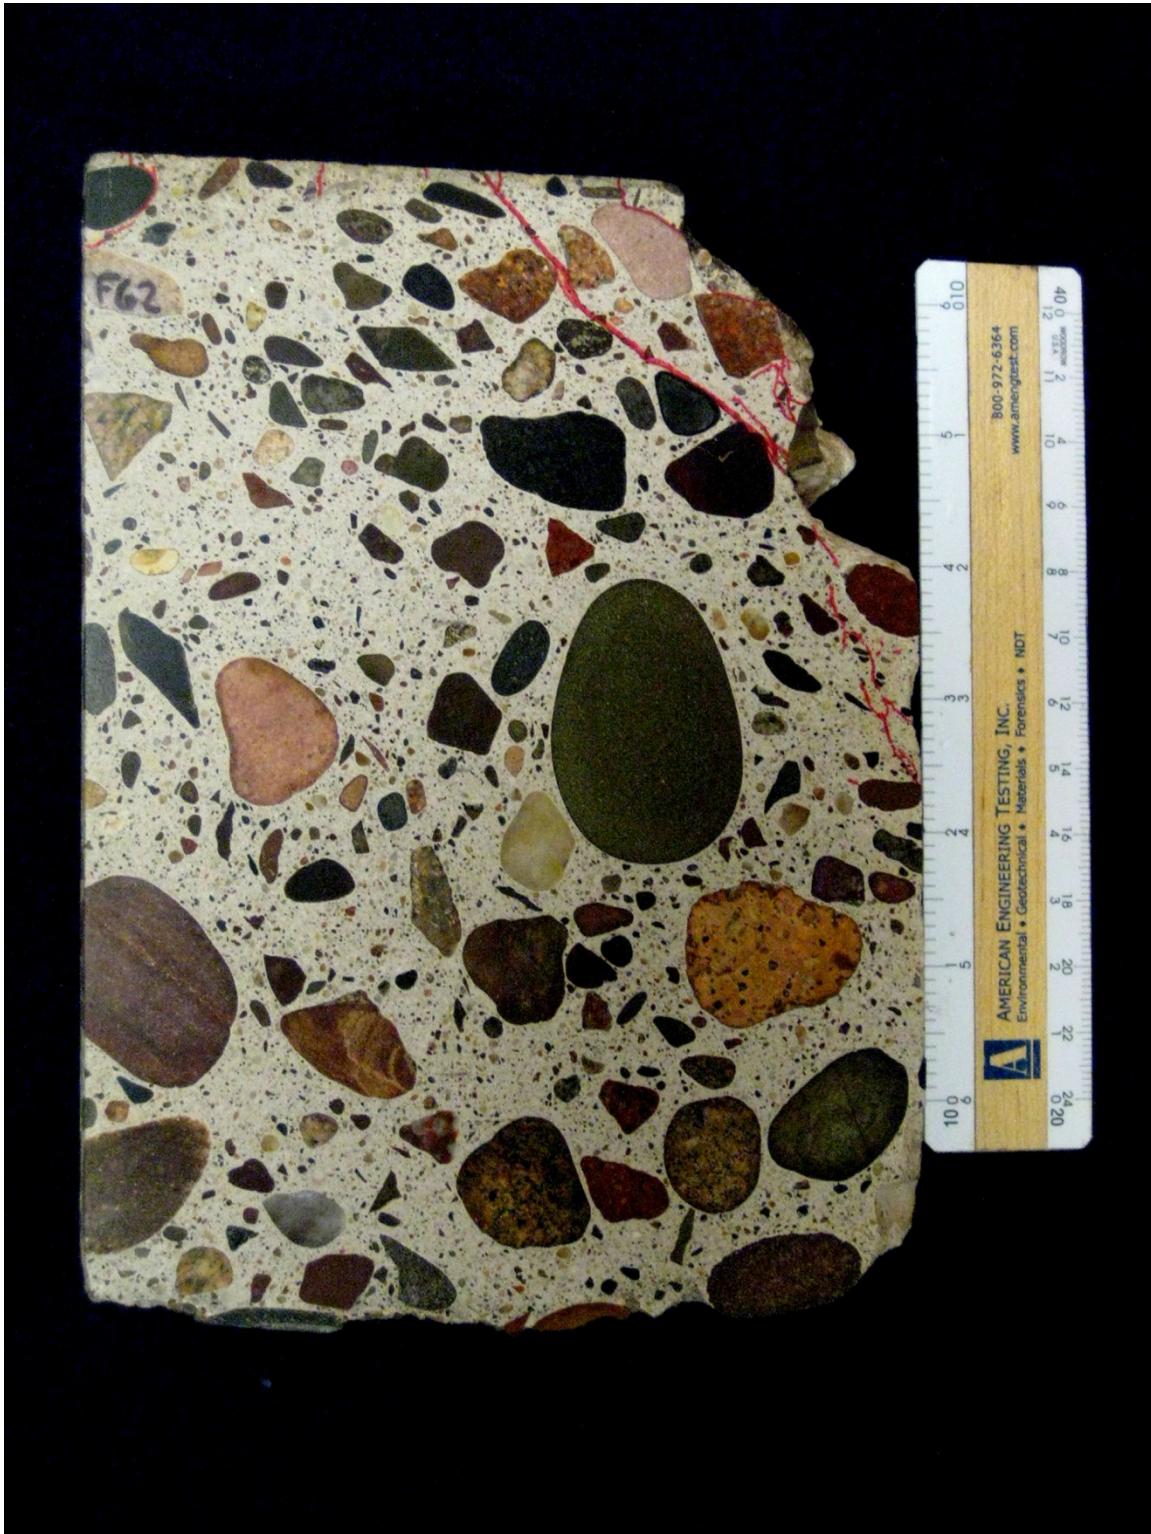
PHOTO: 10

SAMPLE ID: FG-2 **DESCRIPTION:** Sawcut and lapped cross section of core apparently taken directly adjacent to a distressed control joint. Microcracking is mapped in red ink.

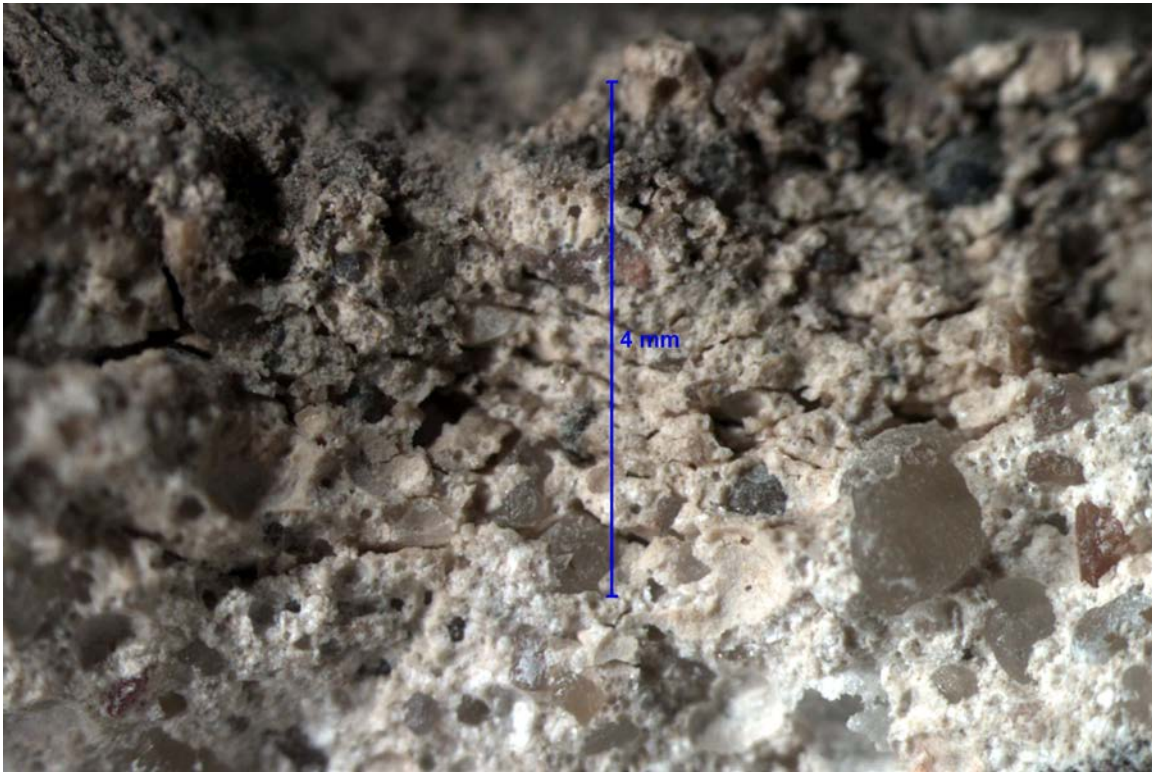
PHOTO: 13

SAMPLE ID: FG1 **DESCRIPTION:** Highly concentrated anastomosing microcracking in carbonated paste directly adjacent to distressed joint plane (top of image); in freshly fractured cross sectional surface of core.
MAG: 15x

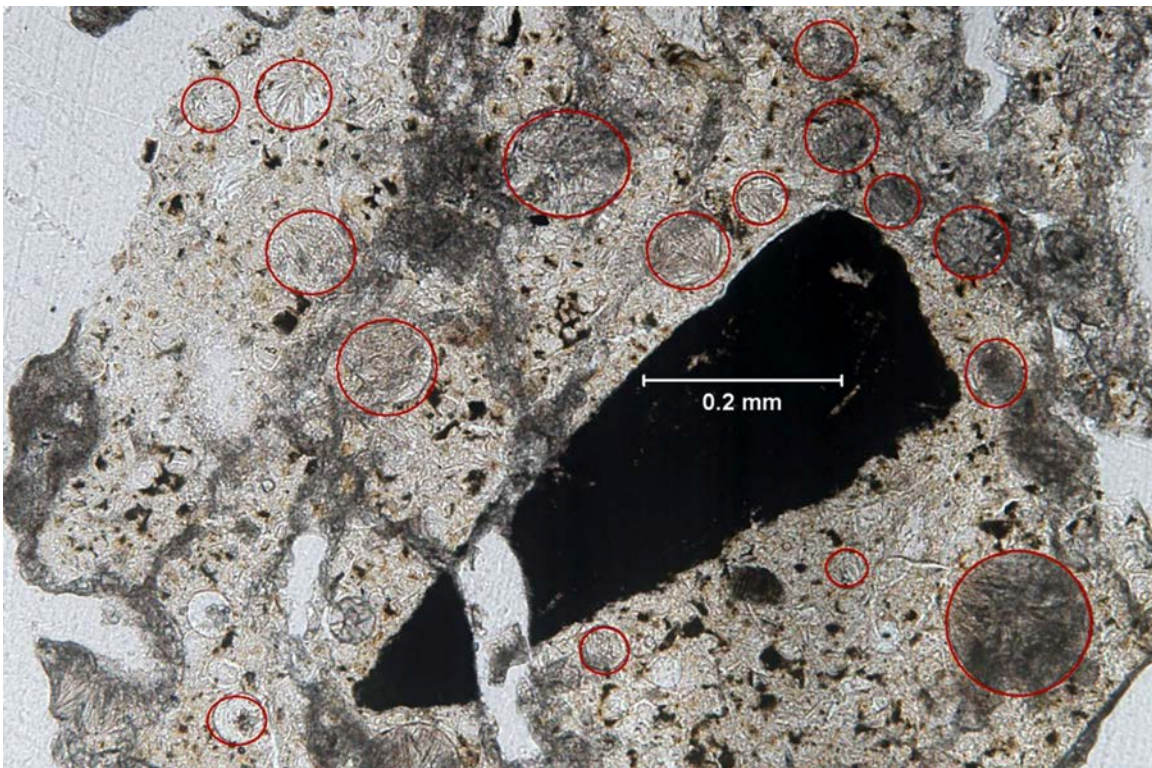
PHOTO: 14

SAMPLE ID: FG1 **DESCRIPTION:** Secondary ettringite and calcite fills fine air voidspaces (outlined in red) in thin section of the altered and highly distressed paste directly adjacent to the joint crack at below approx. 75mm depth in the core.
MAG: 100x

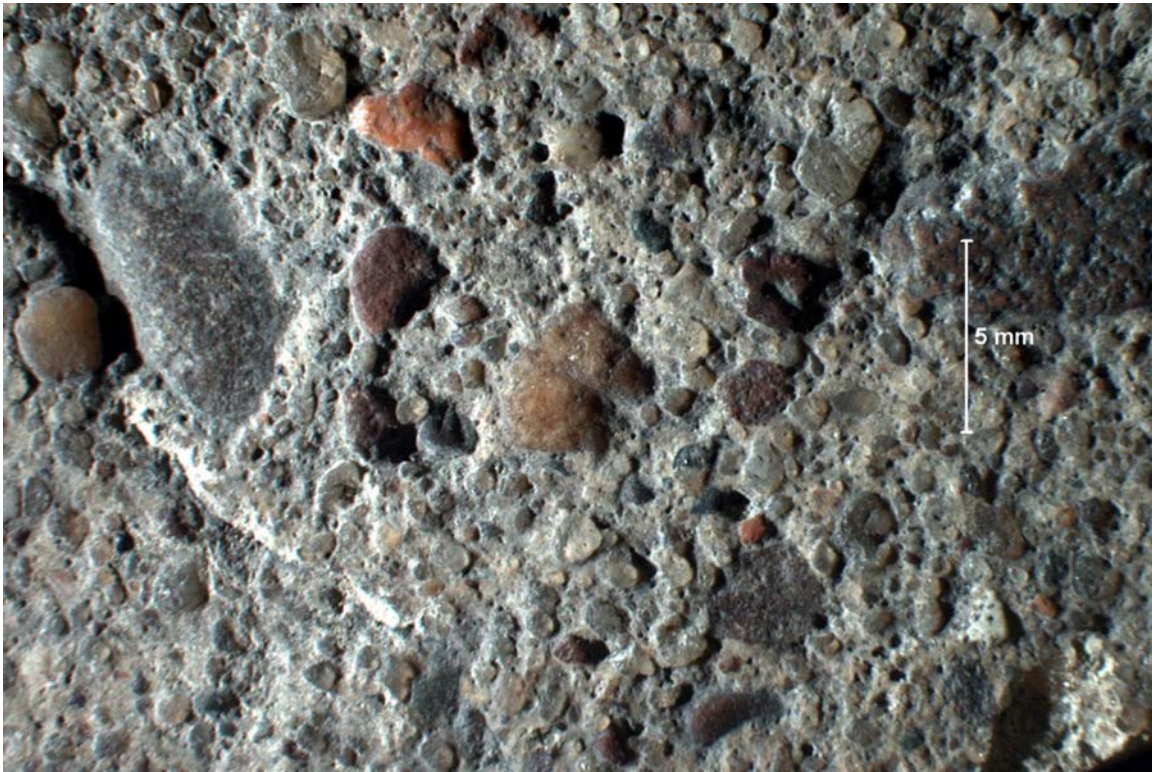
PHOTO: 31

SAMPLE ID: FG4 **DESCRIPTION:** Traffic-worn and mortar eroded top surface of the core under magnification.

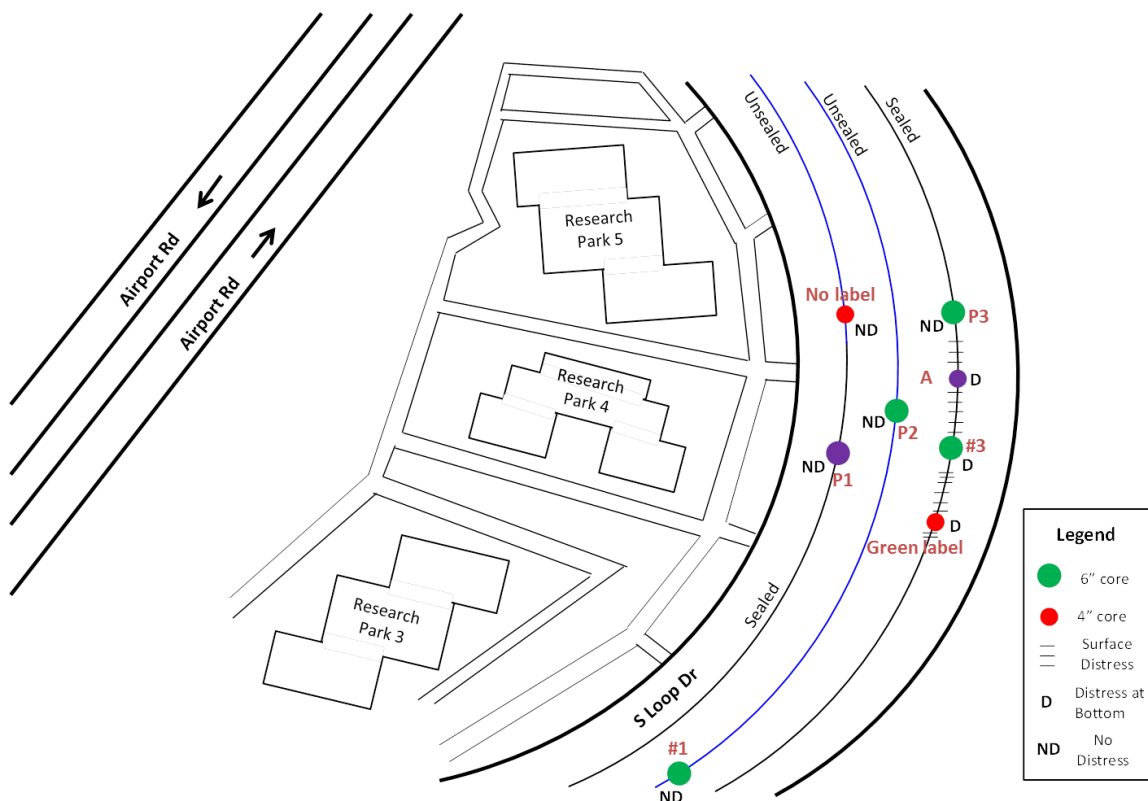
Figure 2. Plan of coring and distress

The extent of the distress was mapped, along with details of where joints had been sealed. (Figure 2).

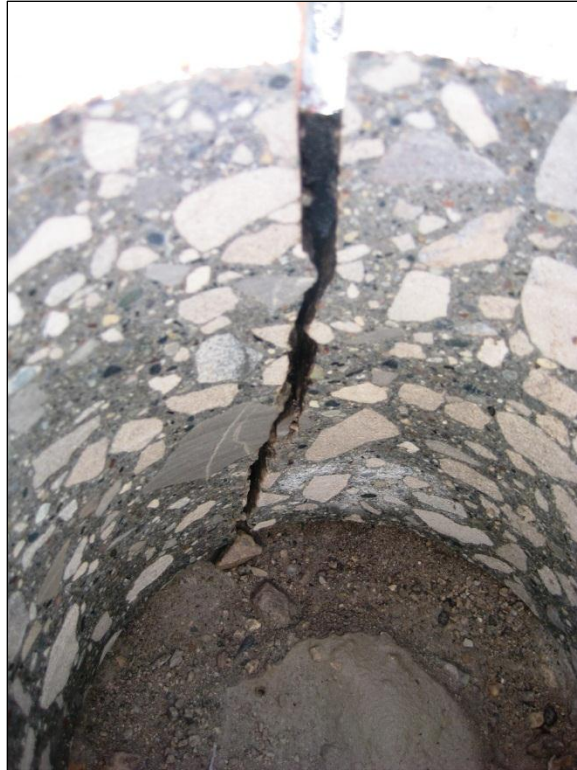
Figure 3. Faulting and loss of aggregate interlock

It is also noted that there is faulting starting to occur in the left-most joint, particularly at the northeast end of the road (Figure 3).

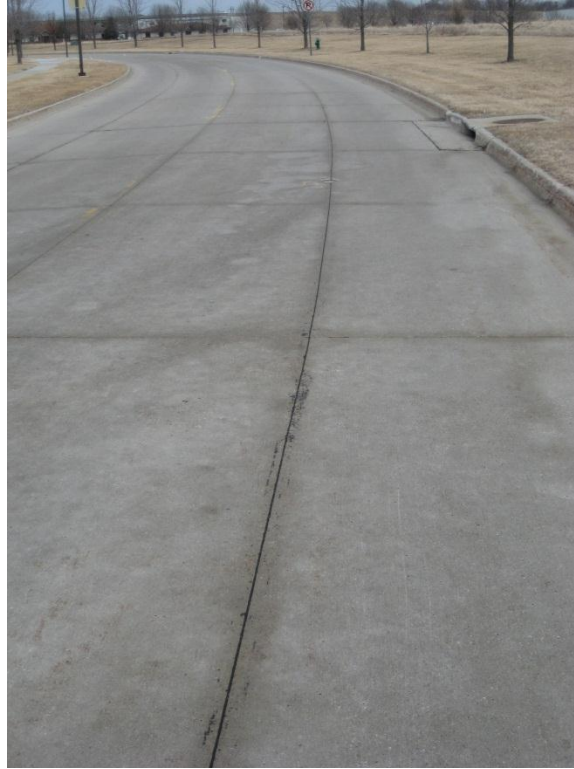
Figure 4. Wet joints and dry pavement

During the winter of 2011/2012 shortly after a light snow event, it was noted that contrary to the pattern observed in Figure 1, the joints appeared to be wet while the rest of the pavement had started to dry out. This is attributed to salts collecting in the joints and slowing the rate of drying (Figure 4).

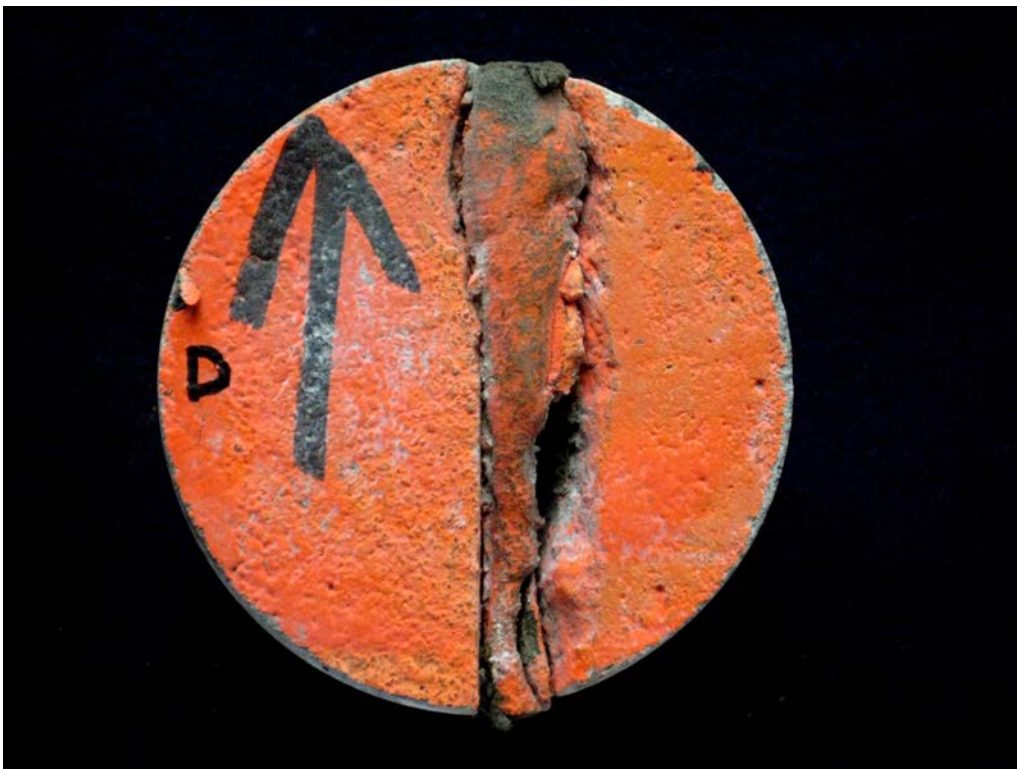
PHOTO: 2

SAMPLE ID: D **DESCRIPTION:** Top surface of the core as received; covered by orange marking paint. Note core was taken through sawcut control joint; which subsequently "sliver spalled" and was filled with hot-pour joint sealant (now de-bonded).

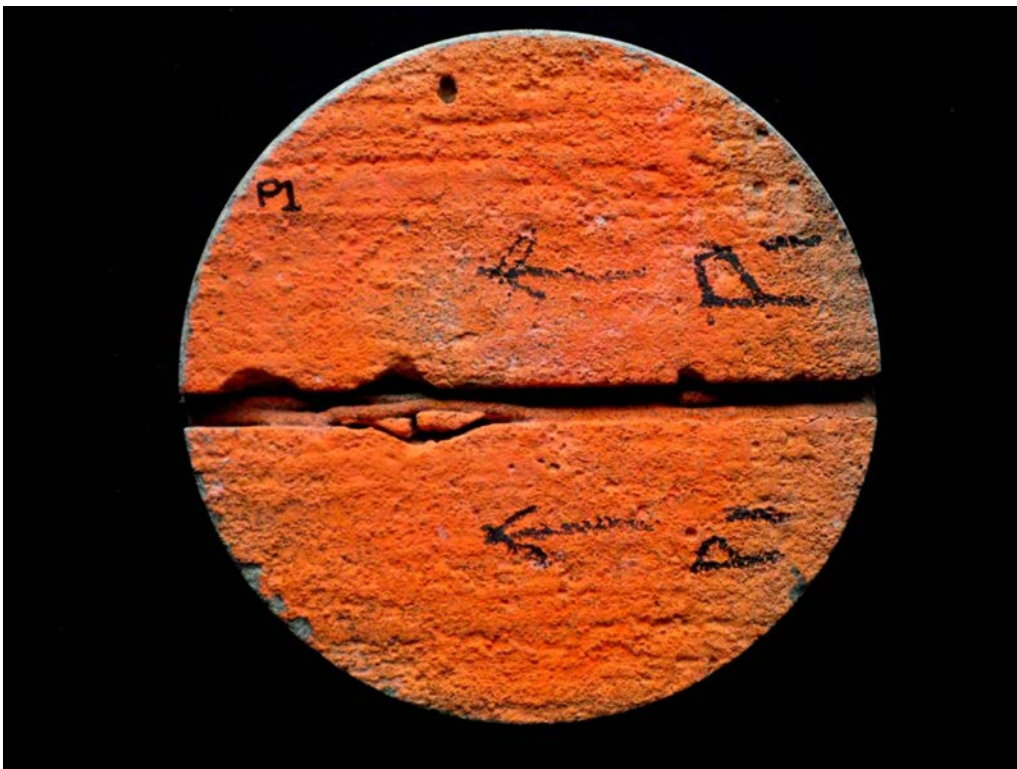
PHOTO: 4

SAMPLE ID: P1 **DESCRIPTION:** Top surface of the core as received; covered by orange marking paint. Note core was taken through a sawcut control joint; which exhibits intermittent “sliver spalling”. The joint was filled with hot-pour joint sealant.

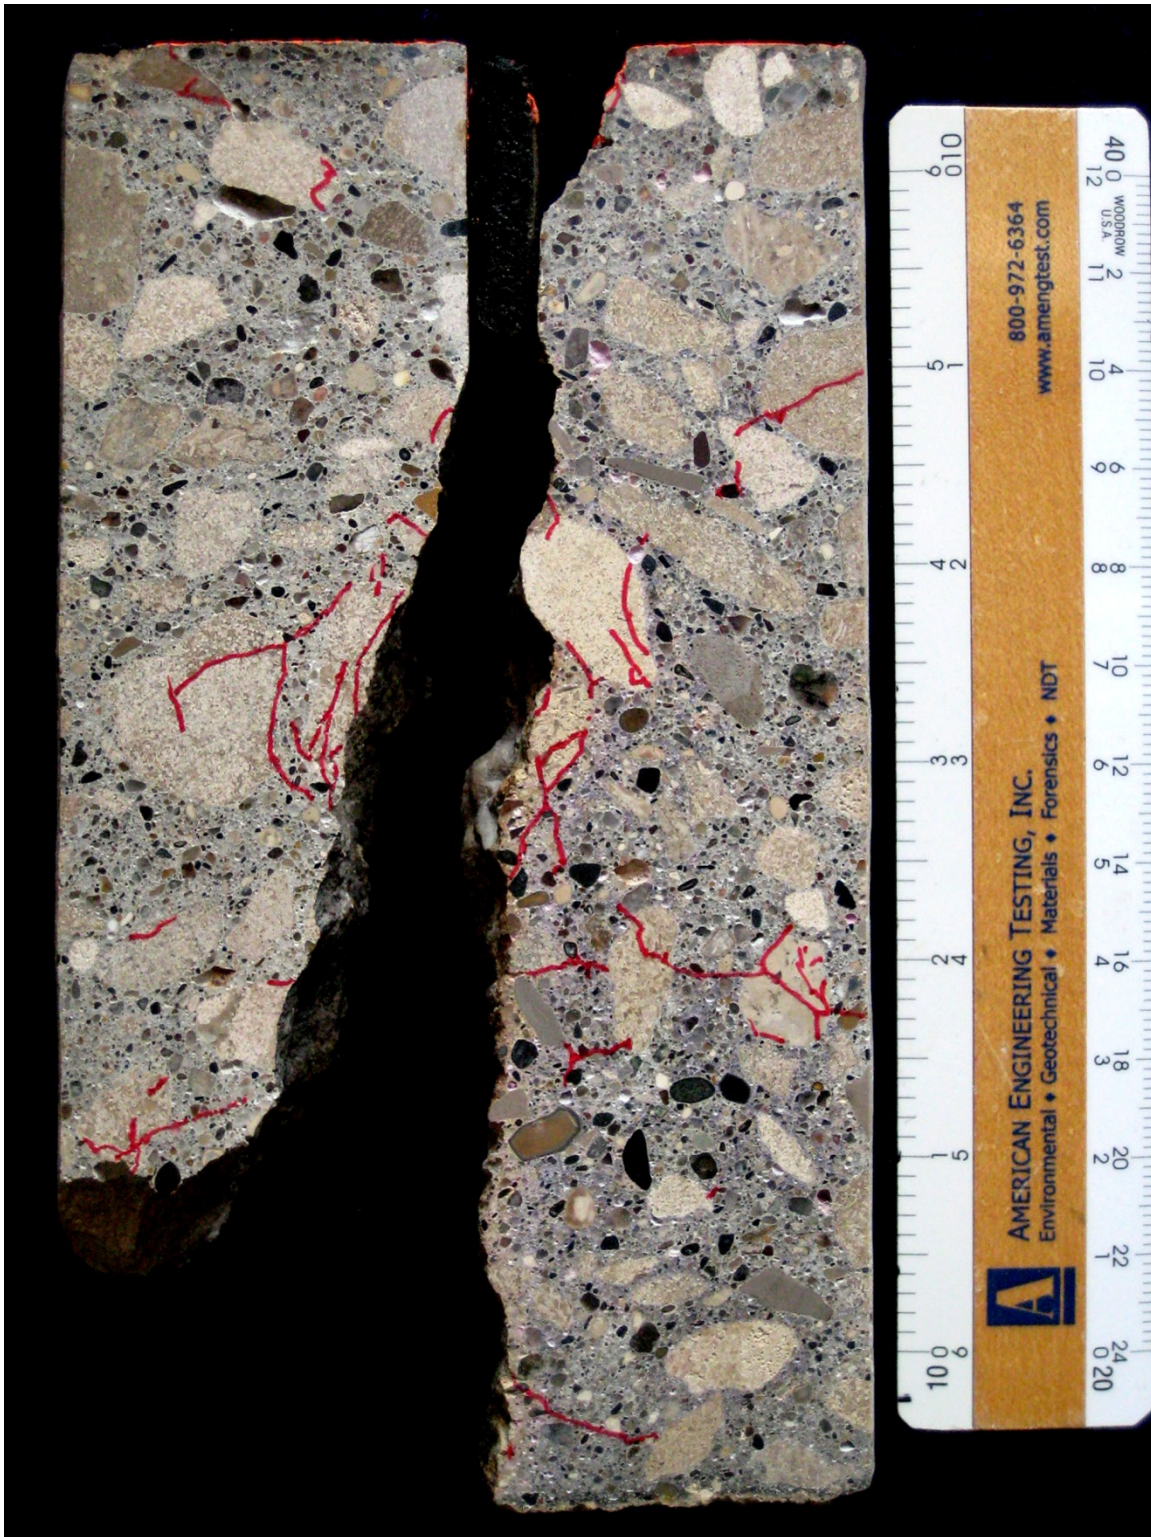
PHOTO: 7

SAMPLE ID: D **DESCRIPTION:** Sawcut and lapped cross section of core taken through joint. Microcracking is mapped in red ink. Note mass lost along the joint crack and cracking within coarse aggregate particles.

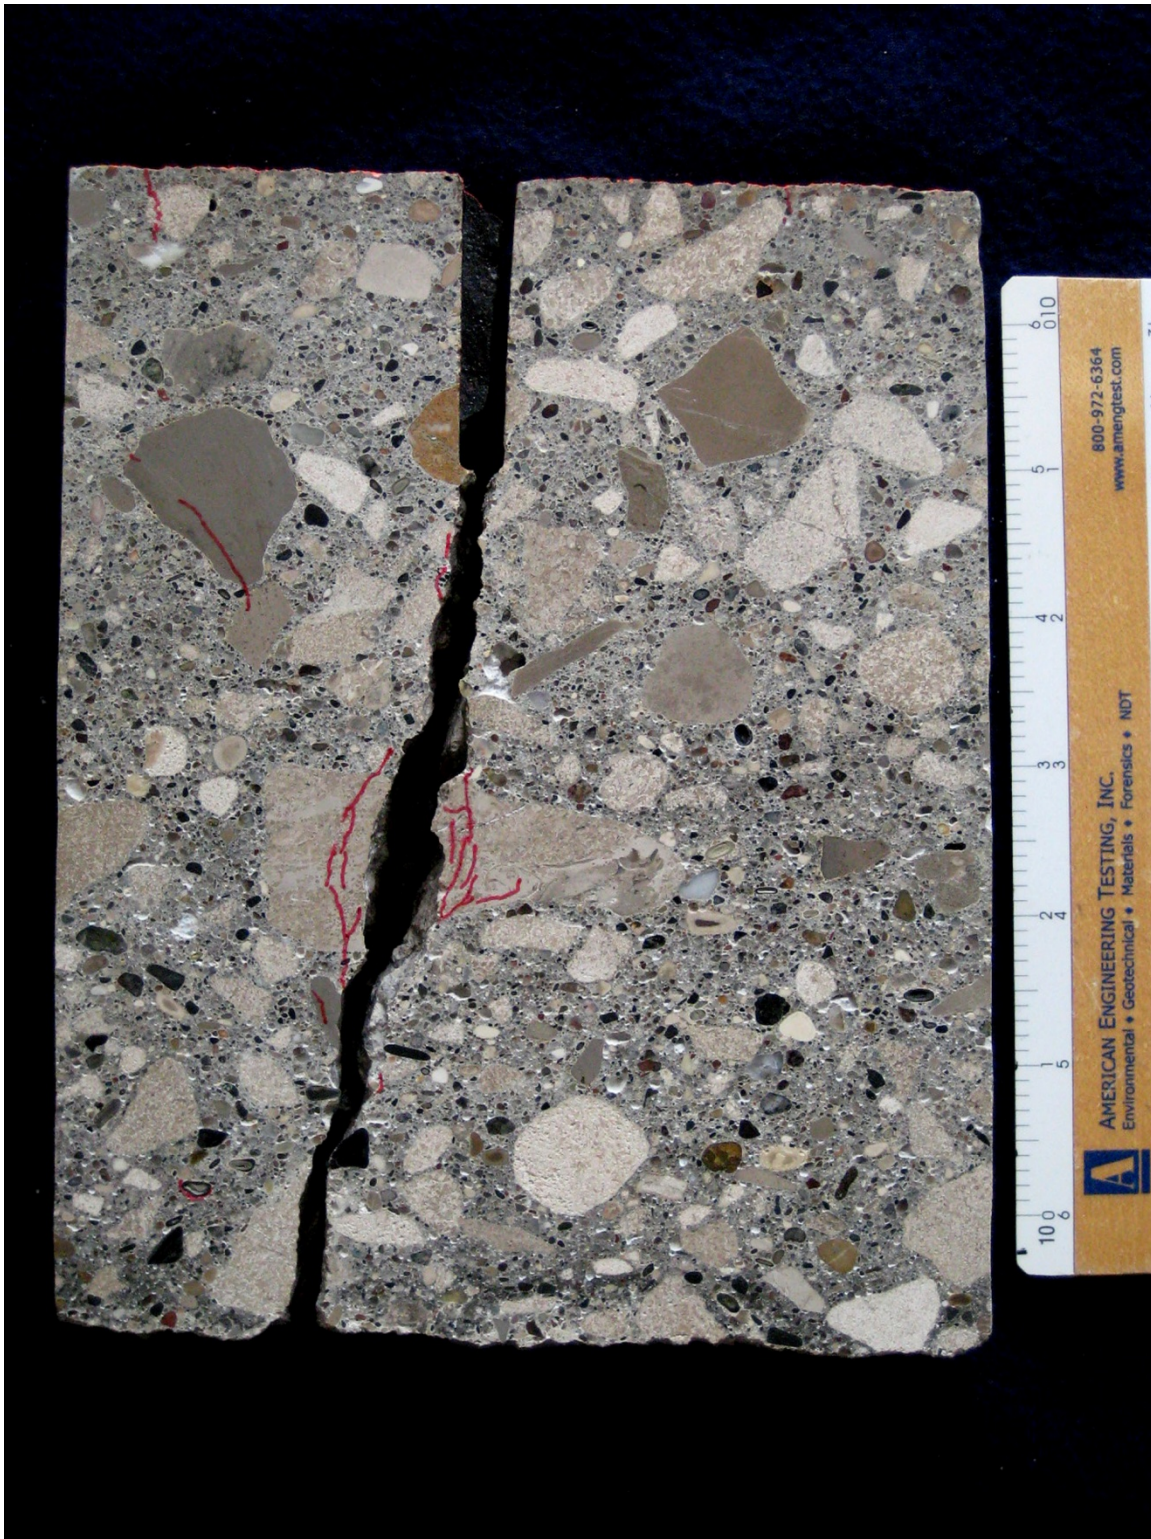
PHOTO: 8

SAMPLE ID: P1 **DESCRIPTION:** Sawcut and lapped cross section of core taken through joint. Microcracking is mapped in red ink. Note mass lost along the joint crack and cracking within the coarse aggregate particle bisected by the joint.

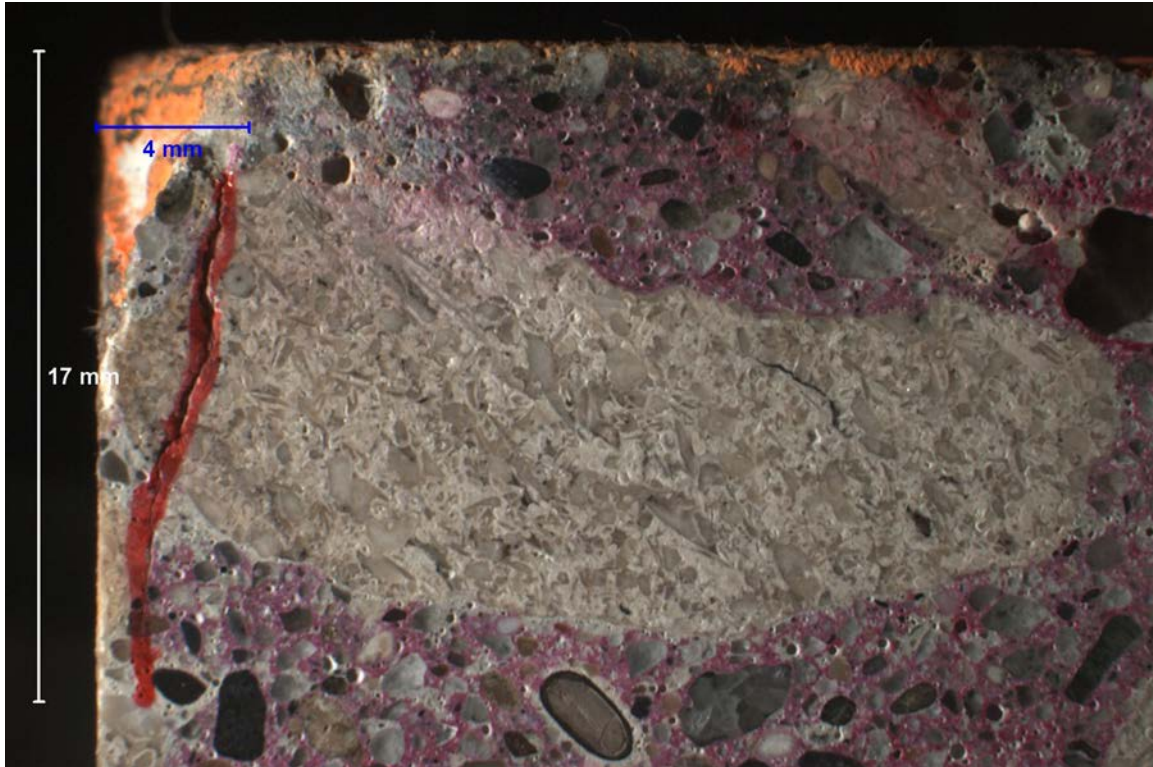
PHOTO: 11

SAMPLE ID: D **DESCRIPTION:** Incipient sliver spalling in sawcut and lapped cross section of concrete at joint (left).

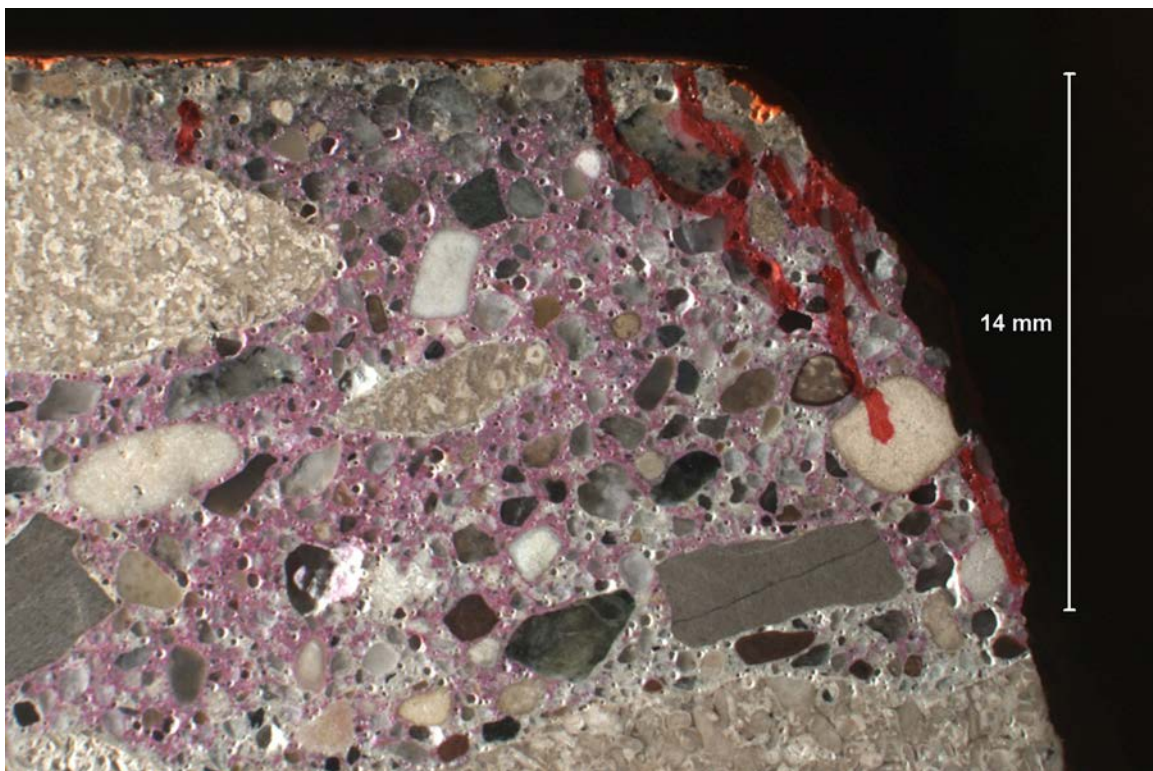
PHOTO: 12

SAMPLE ID: D **DESCRIPTION:** Another sawcut and lapped section of core exhibiting sliver spalling and incipient spalling mapped in red ink.

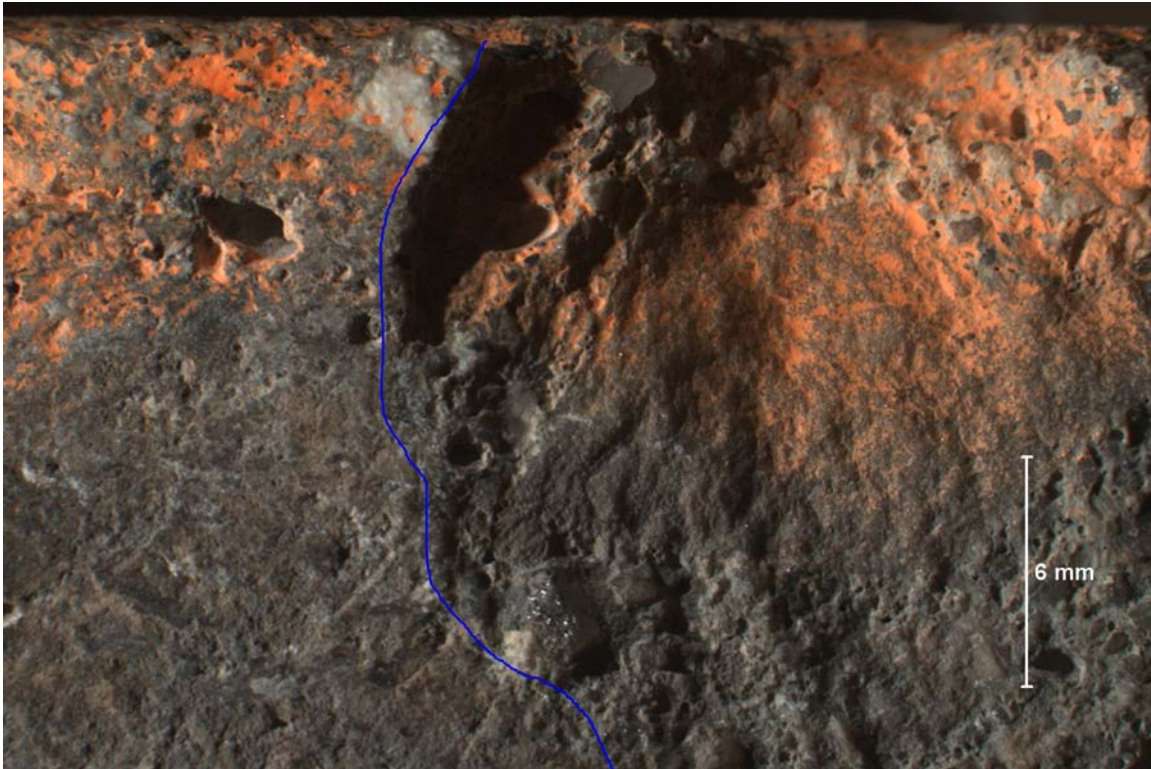
PHOTO: 21

SAMPLE ID: P1 **DESCRIPTION:** Thin, semi-circular sliver spall (outlined in blue) viewed from within the joint.

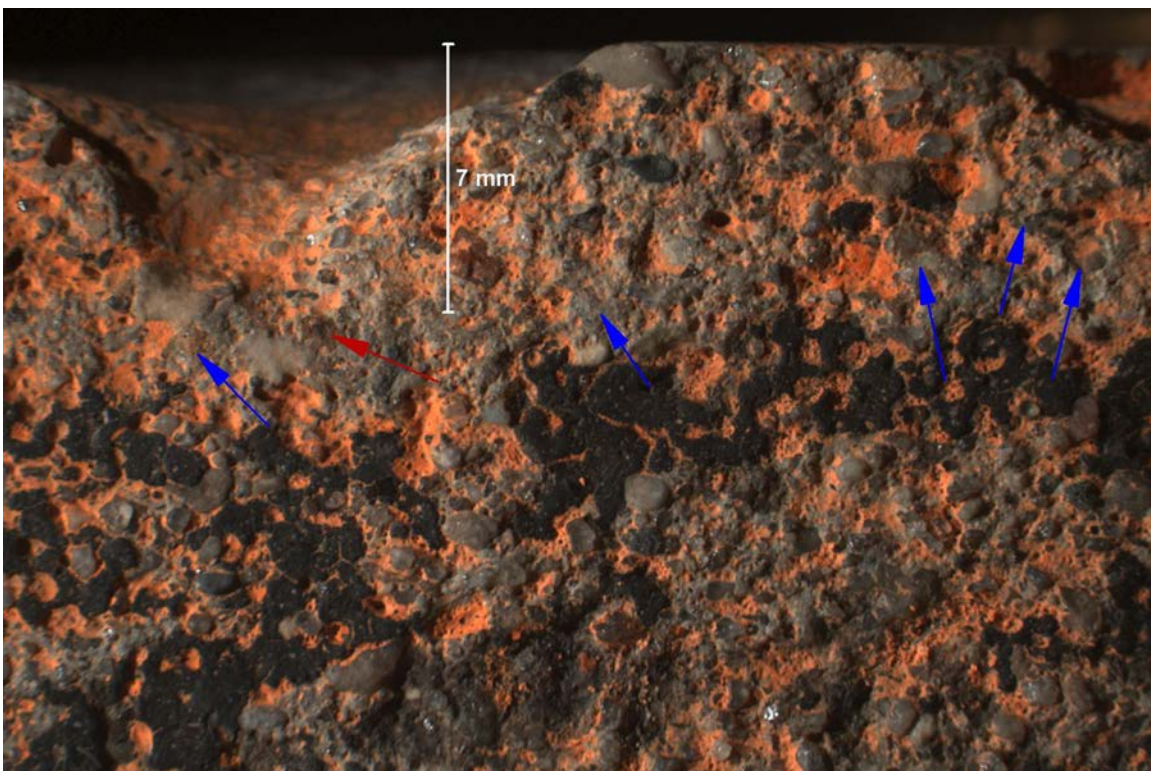
PHOTO: 22

SAMPLE ID: P1 **DESCRIPTION:** View of the mortar eroded top surface and joint (top of image) exhibiting 7mm wide sliver spalling. Arrows mark corroded metal adhered to exposed aggregates on the top surface.

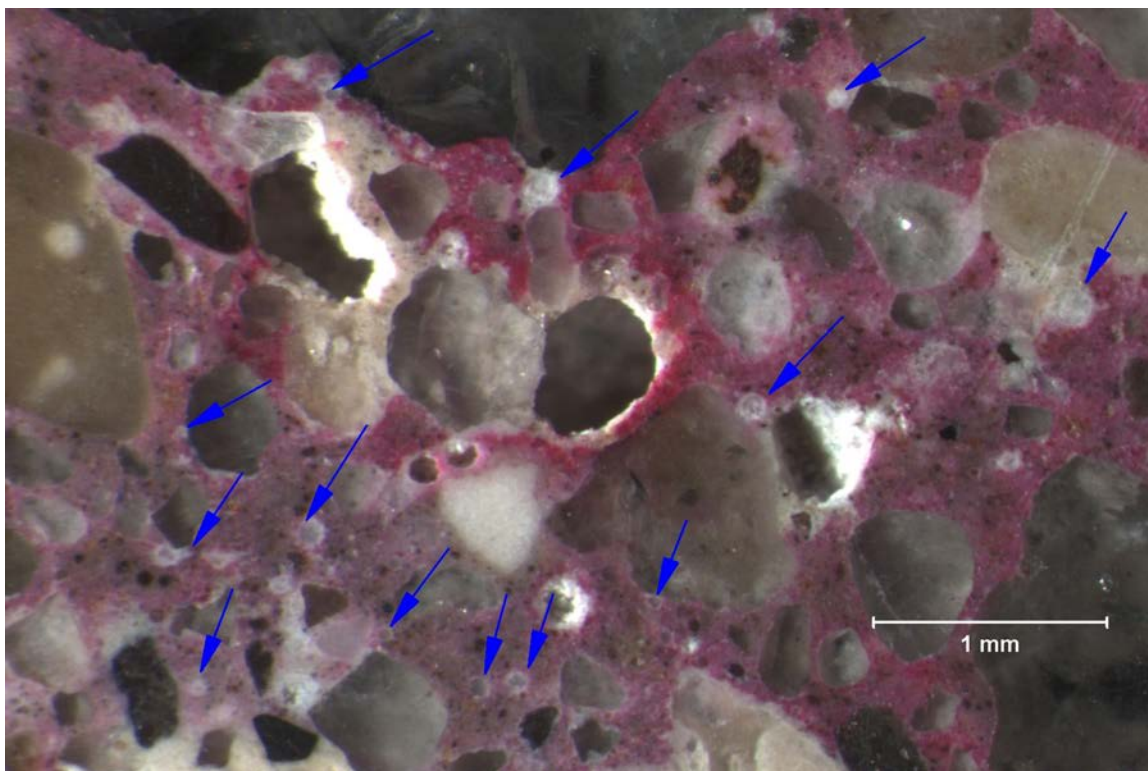
PHOTO: 26

SAMPLE ID: P1 **DESCRIPTION:** White to clear ettringite-filled voids in phenolphthalein-stained paste within 20mm of the joint.

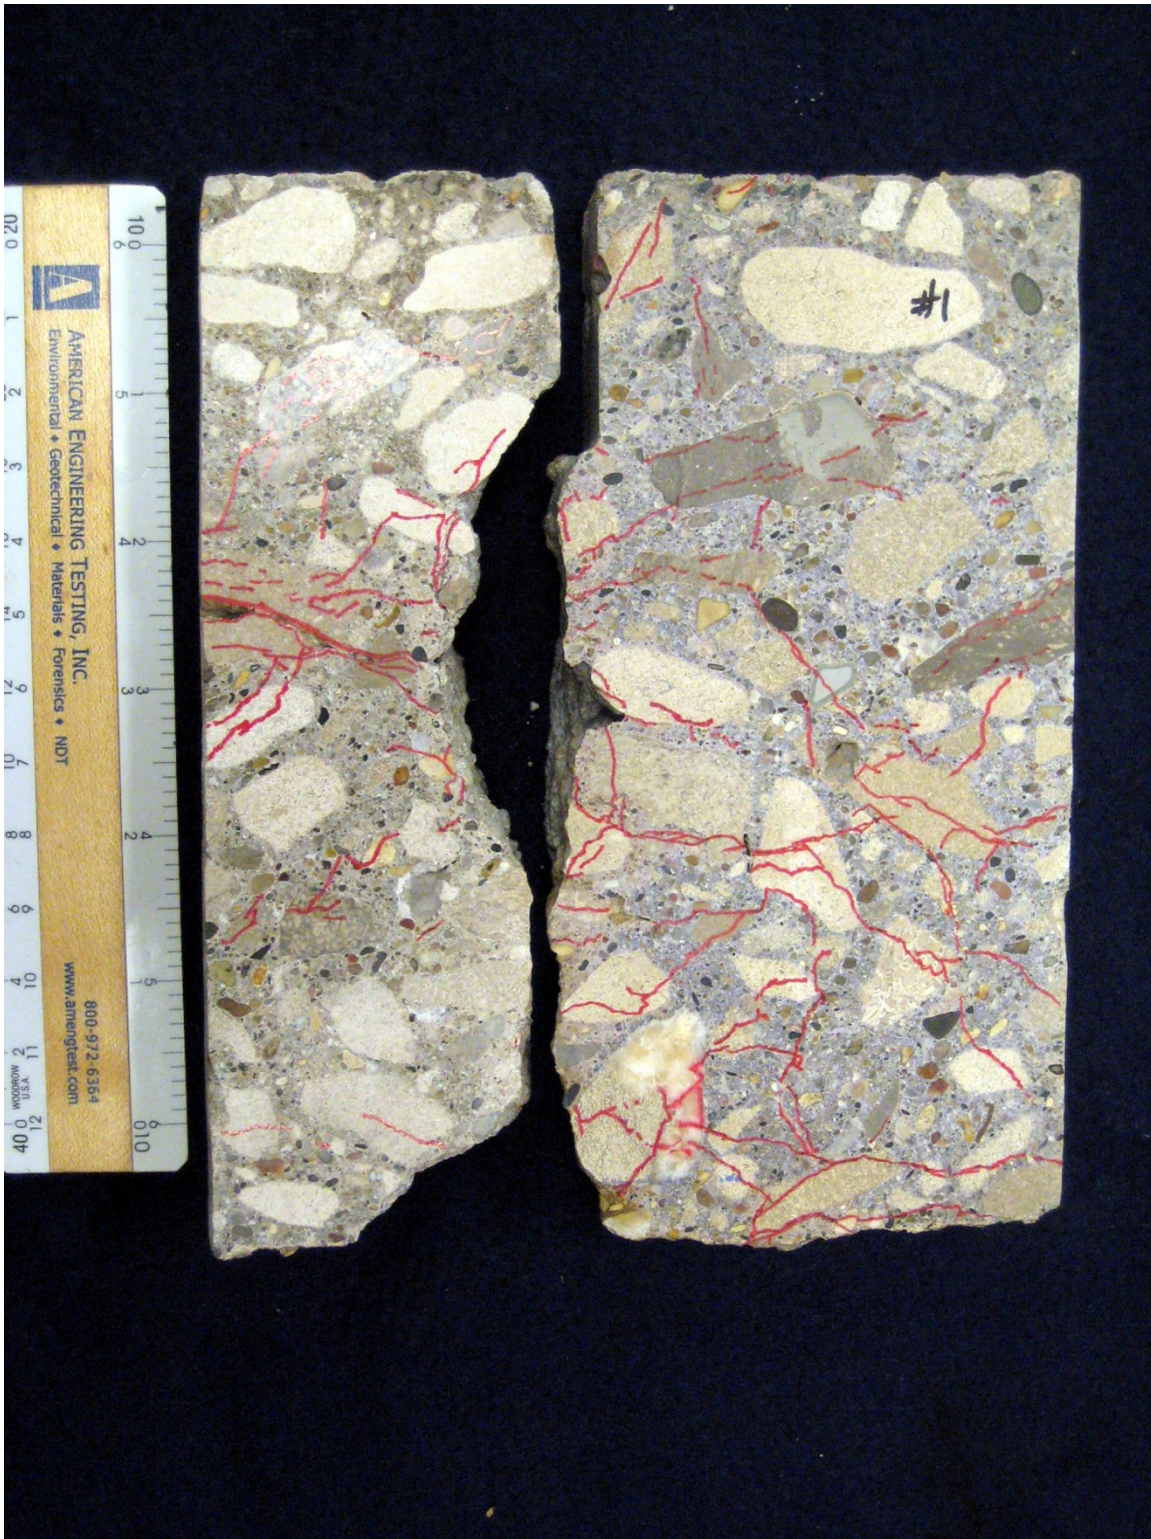
PHOTO: 5

SAMPLE ID: #1 **DESCRIPTION:** Sawcut and lapped cross section of core taken through joint. Microcracking is mapped in red ink. Note mass lost along the joint crack and cracking generally concentrated within coarse aggregate particles.

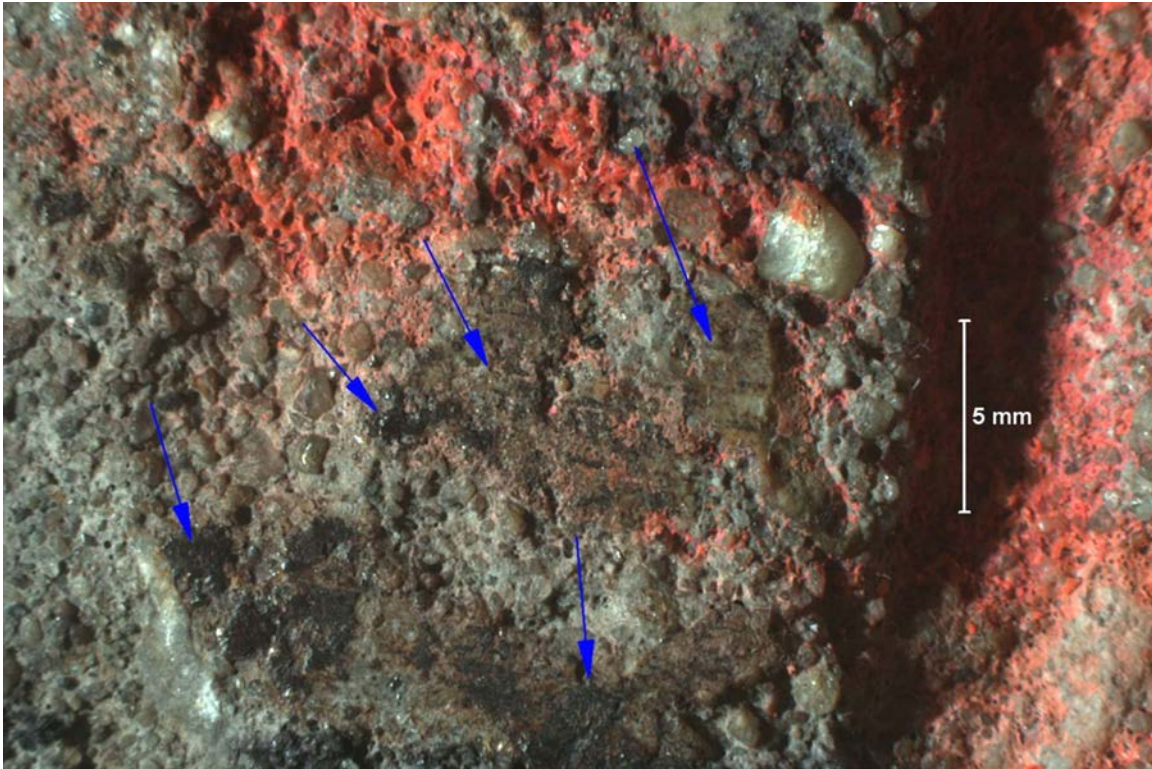
PHOTO: 6

SAMPLE ID: #1 **DESCRIPTION:** Mortar eroded top surface of the core sample with corroded metal adhered to topographic highs in the surface.
MAG: 5x

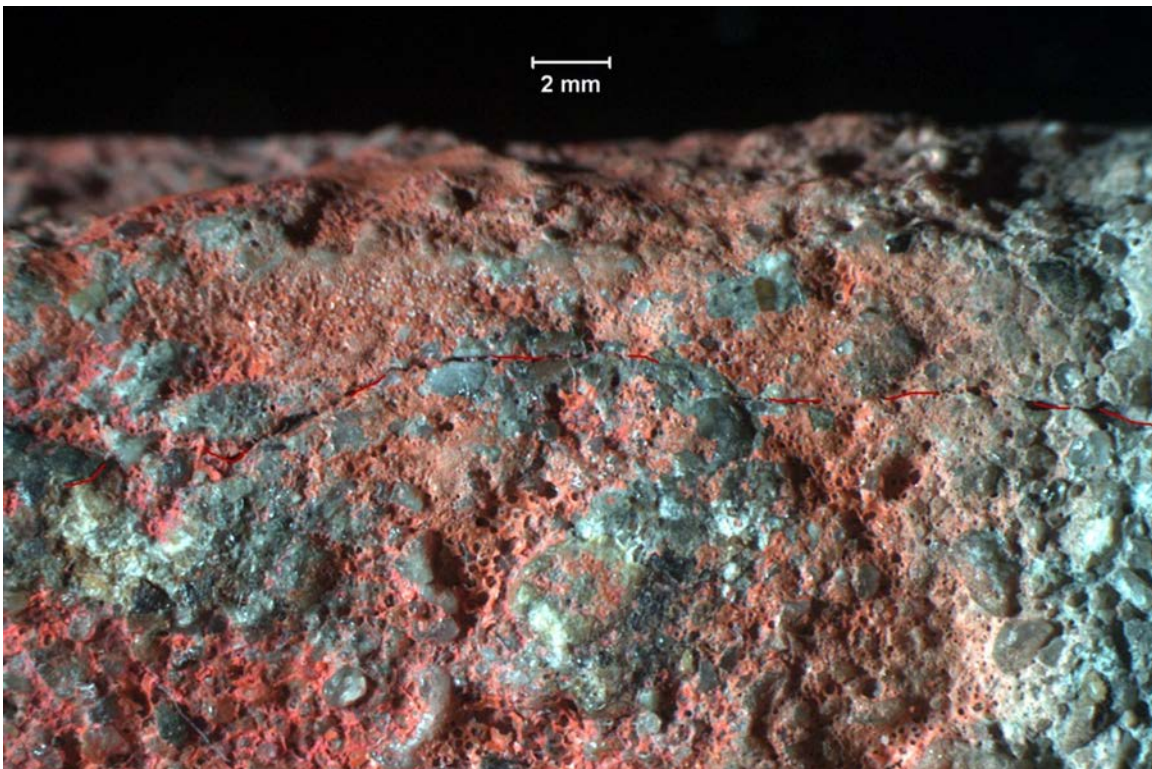
PHOTO: 7

SAMPLE ID: #1 **DESCRIPTION:** Incipient spalling in the top surface of the core sample(mapped in red dashed line), directly adjacent to the joint.
MAG: 5x
